Debris/Ice/TPS Assessment And Photographic Analysis For Shuttle Mission STS-31R

Charles G. Stevenson
NASA/Kennedy Space Center

DEBRIS/ICE/TPS ASSESSMENT
AND
PHOTOGRAPHIC ANALYSIS
OF
SHUTTLE MISSION STS-31R

April 24, 1990

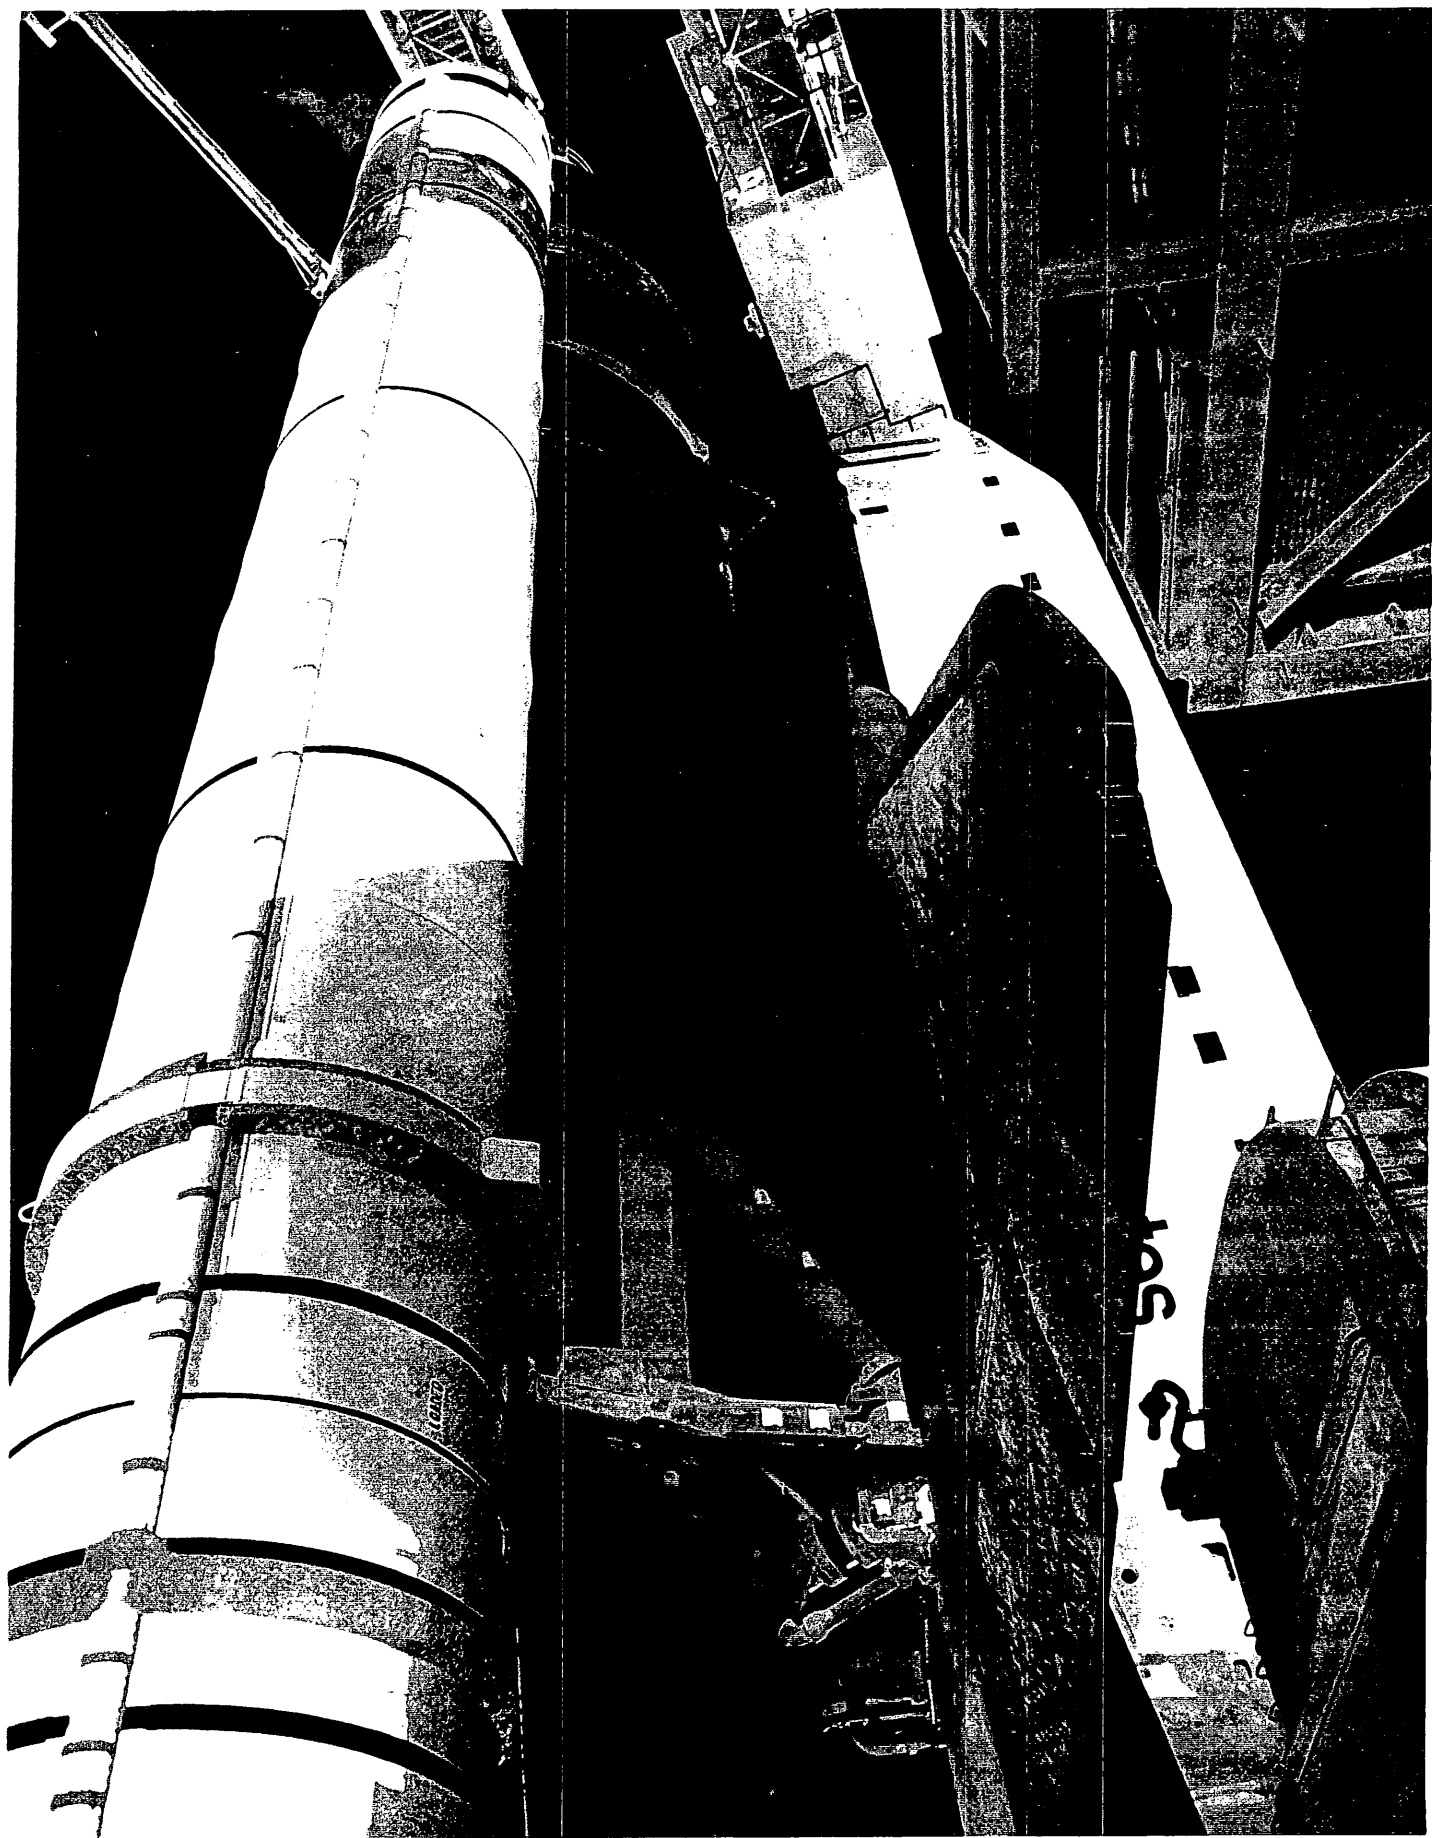
No acreage ice/frost had formed on the -Y+Z side of the tank

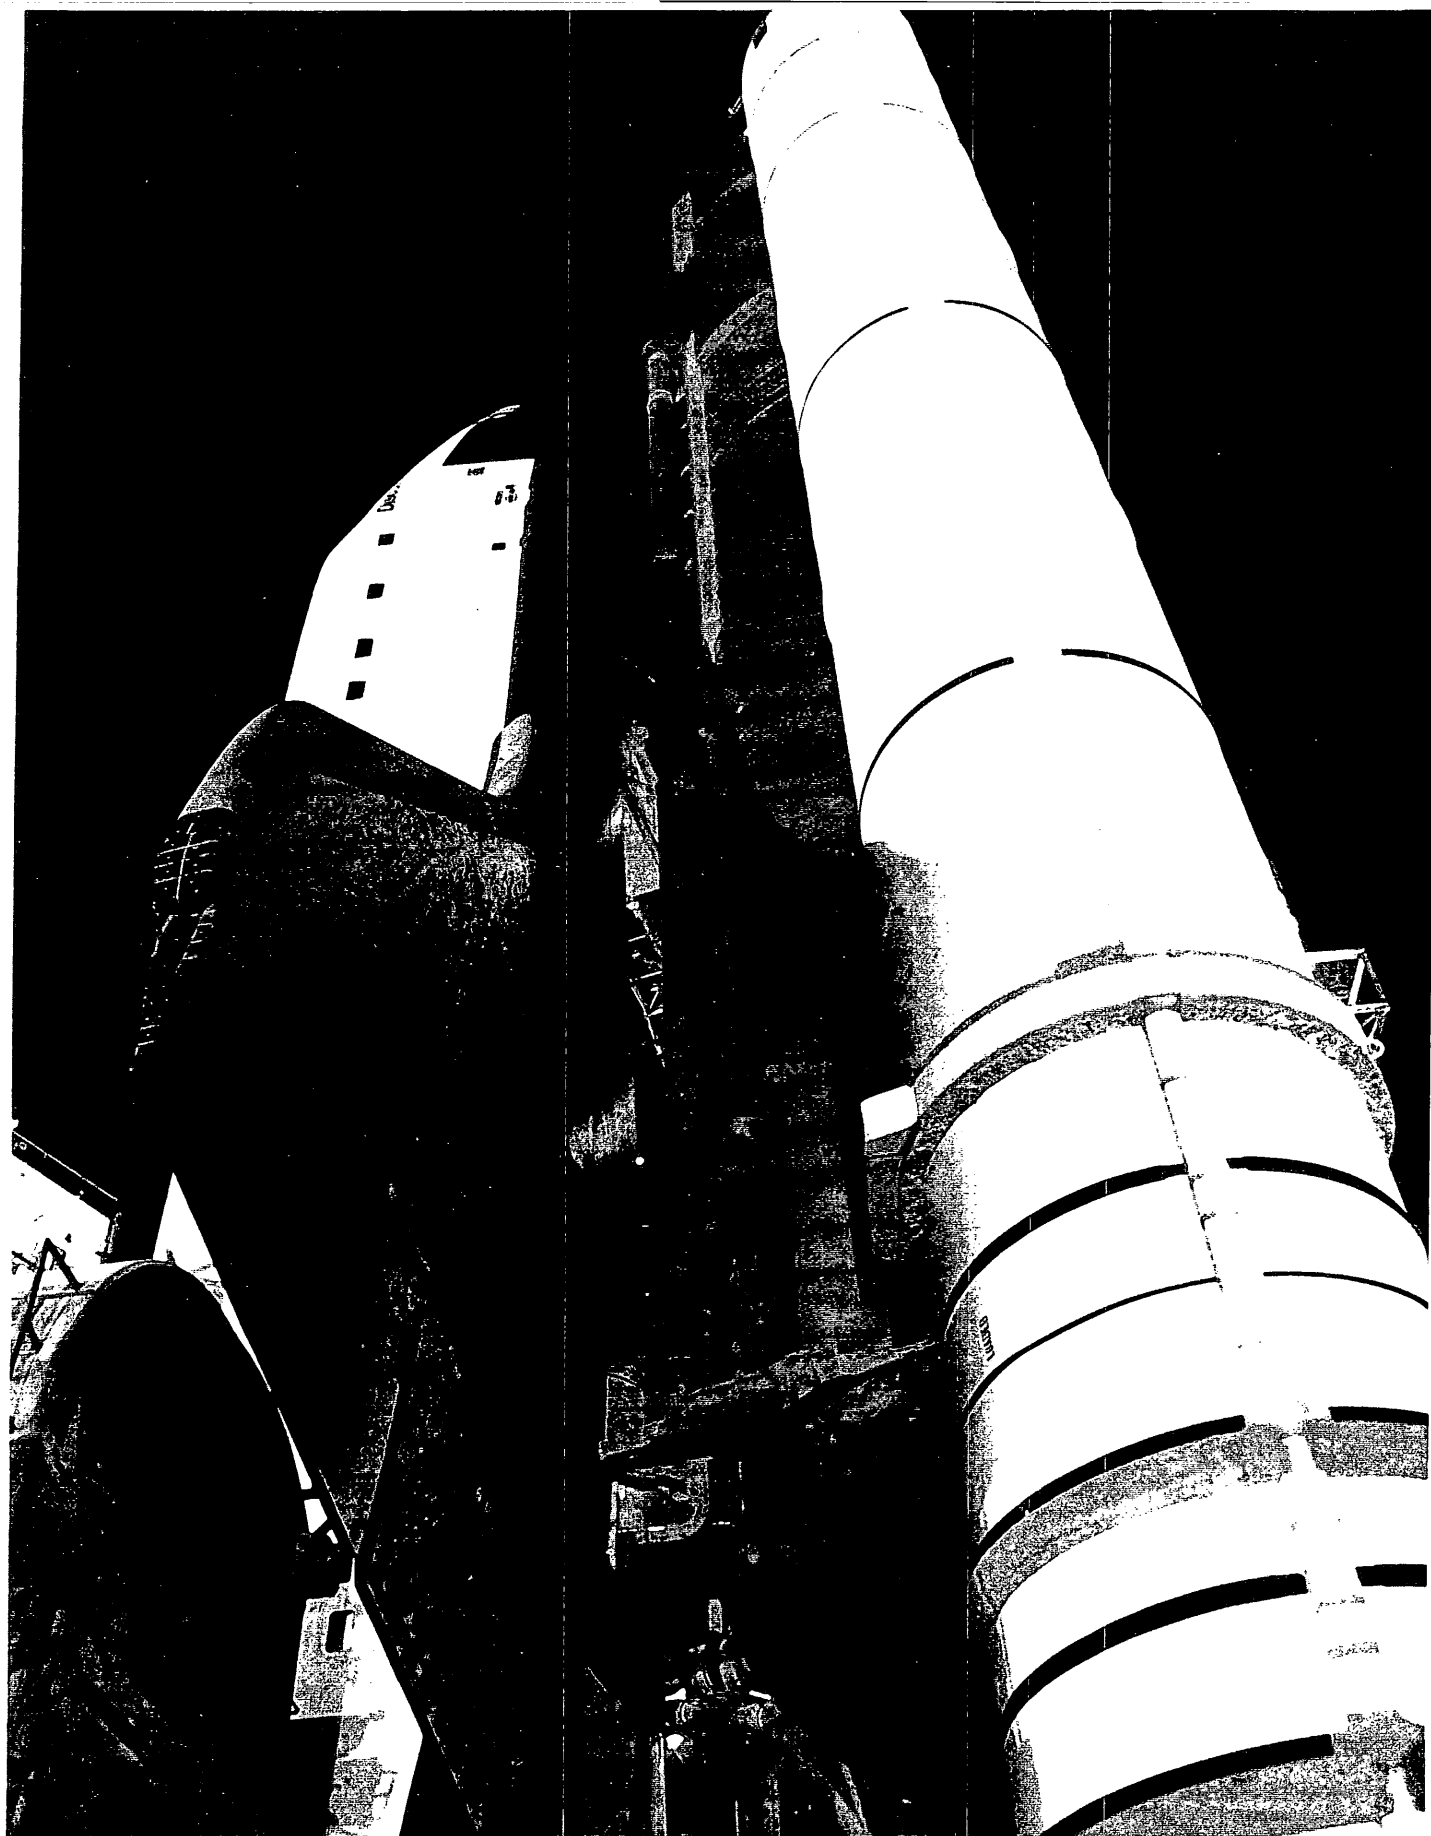
No acreage ice/frost had formed on the +Y+Z side of the tank

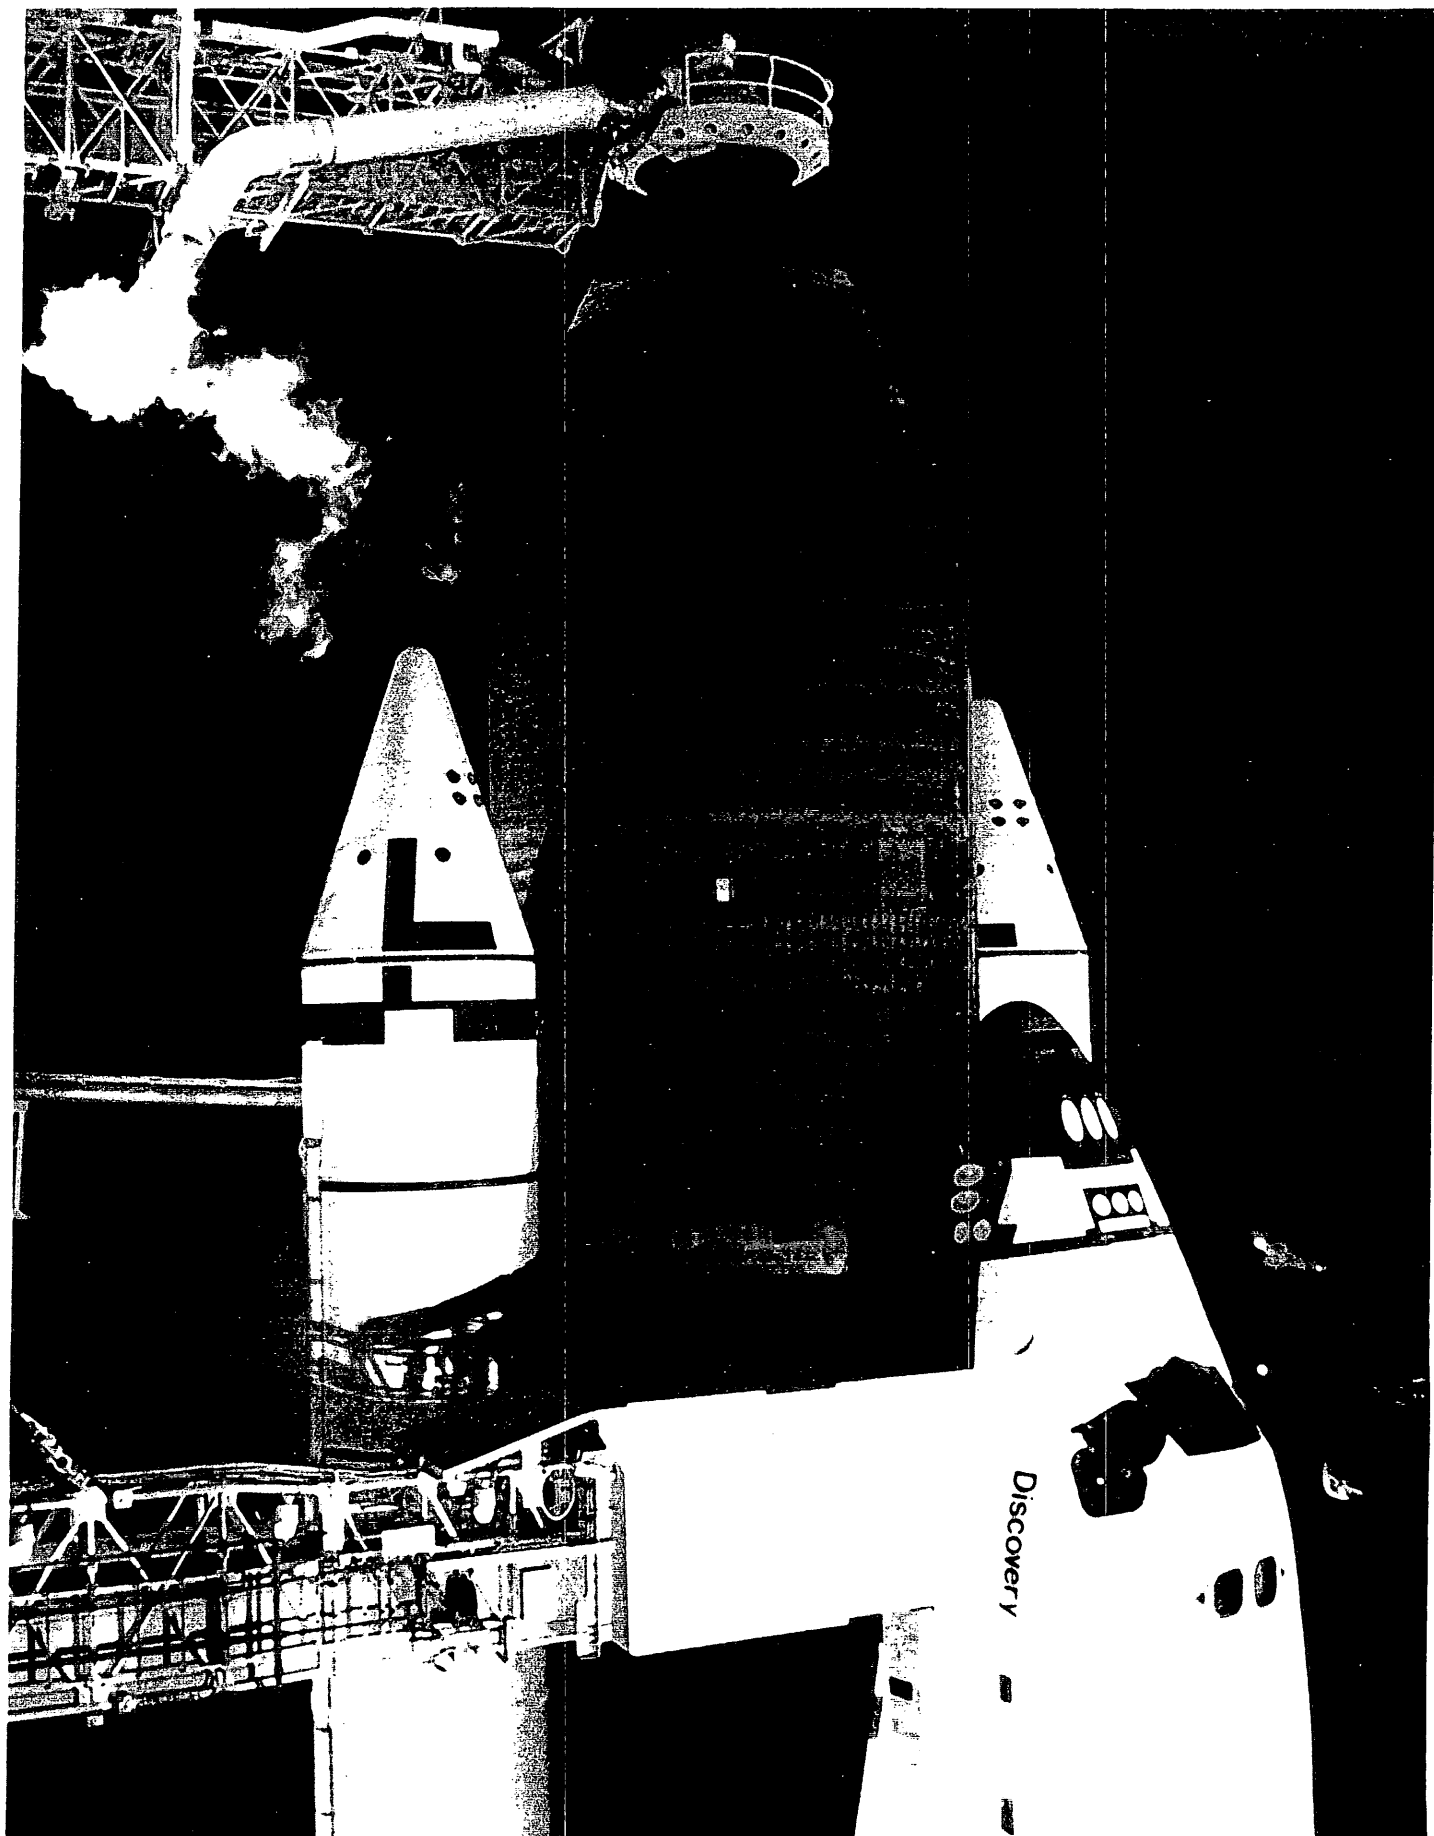
There was no ice/frost accumulation on the LO2 tank ogive or barrel section. GOX duct vapors were not near the vehicle.

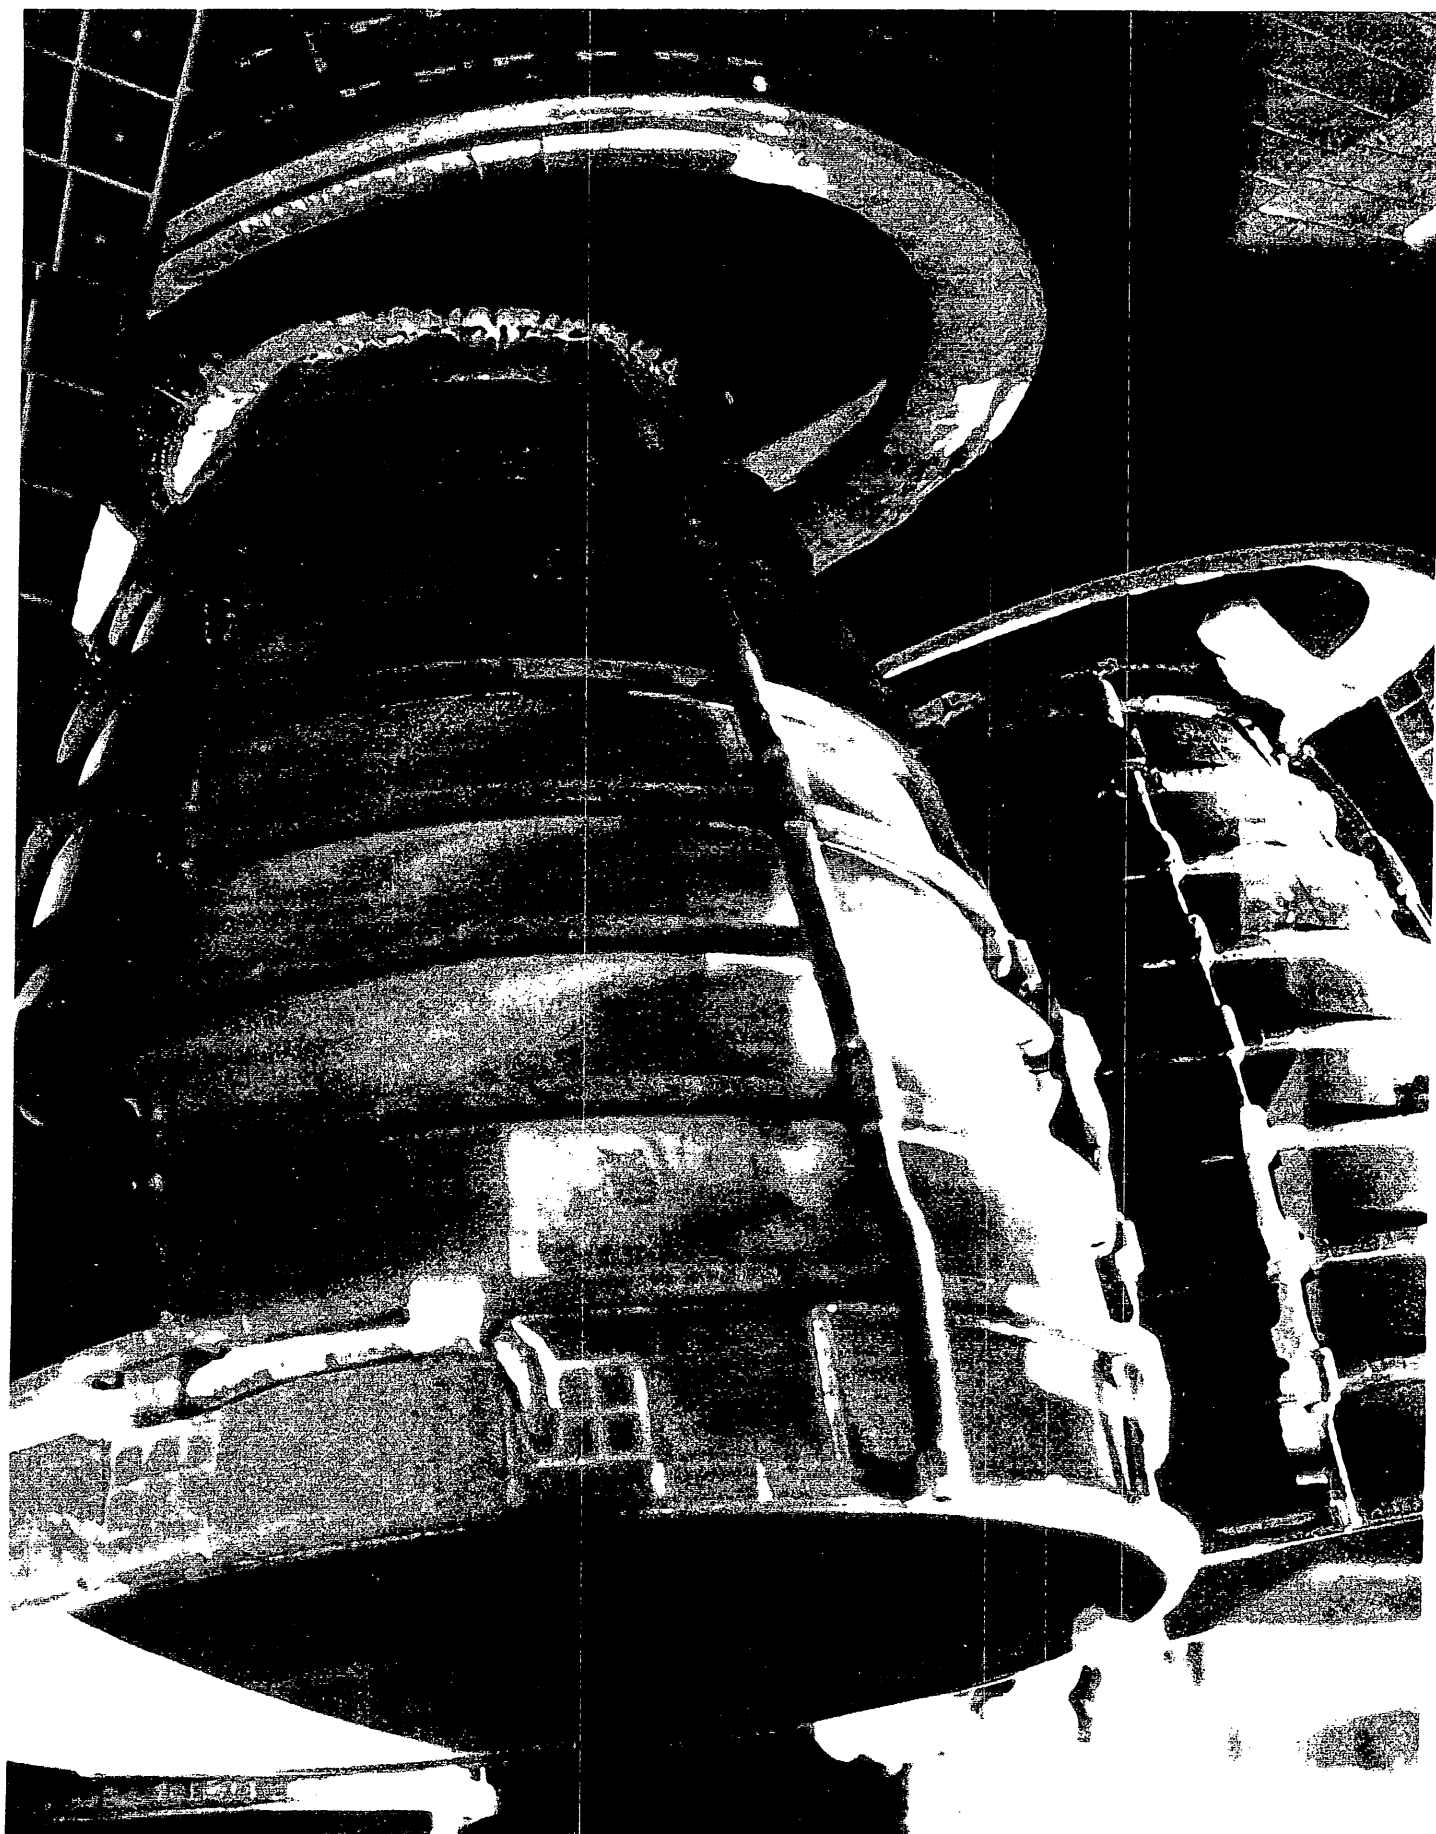
Typical ice/frost has formed at the SSME #1 and #2
nozzle to engine mounted heat shields

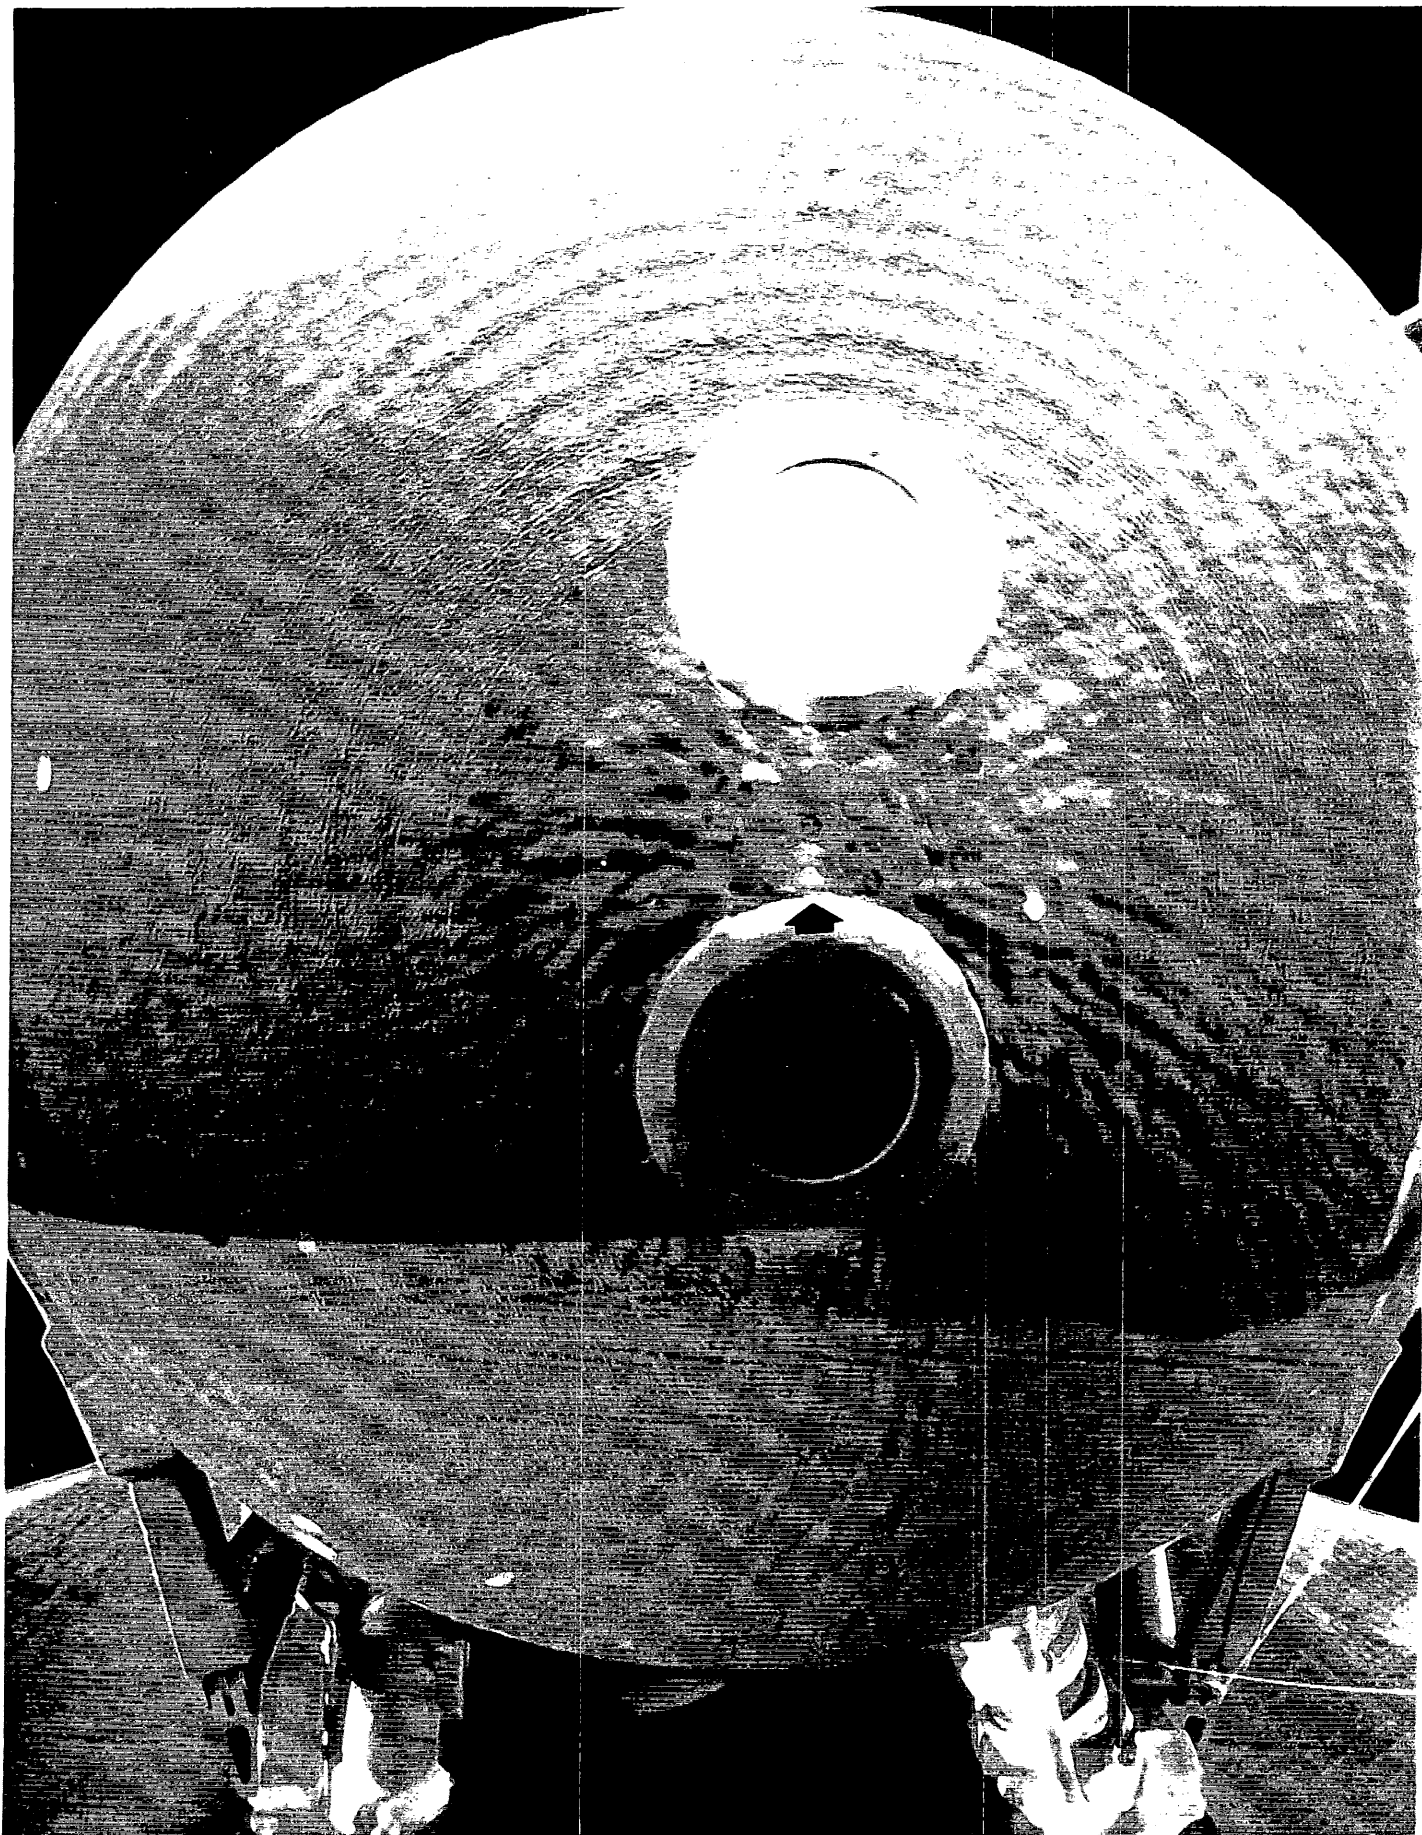
No TPS defects or anomalies occurred on the ET aft dome. No frost formed on the 3-inch diameter apex repair.

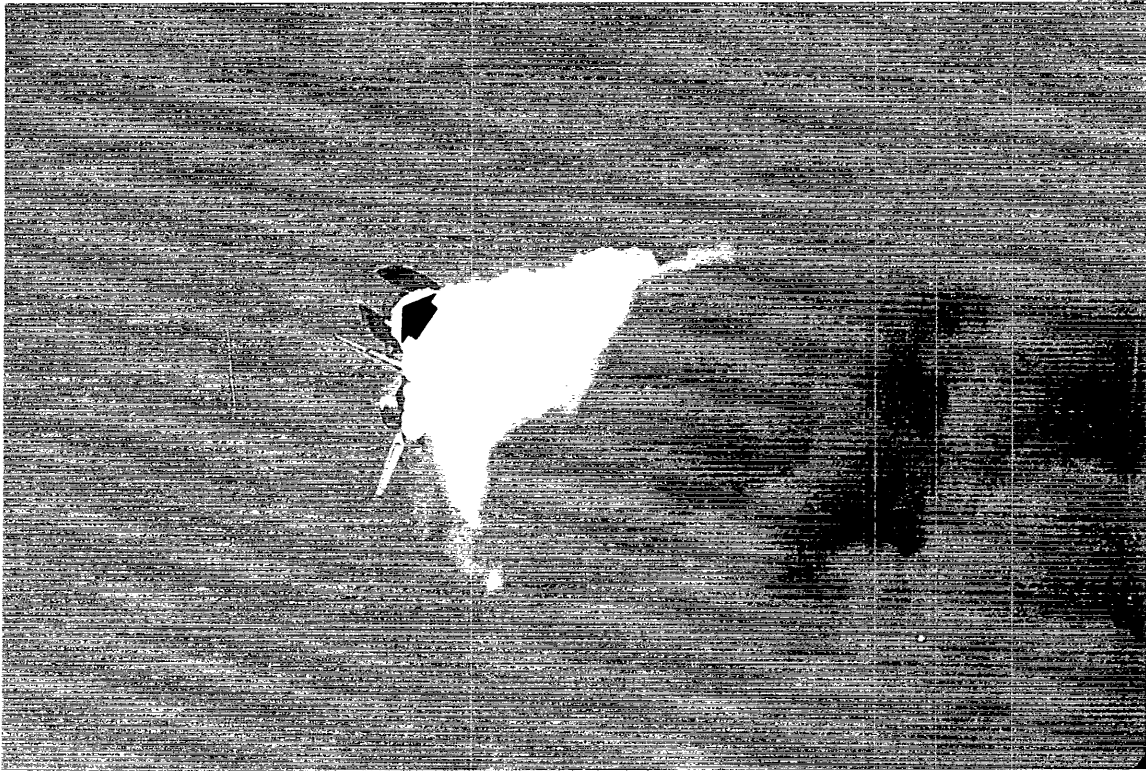
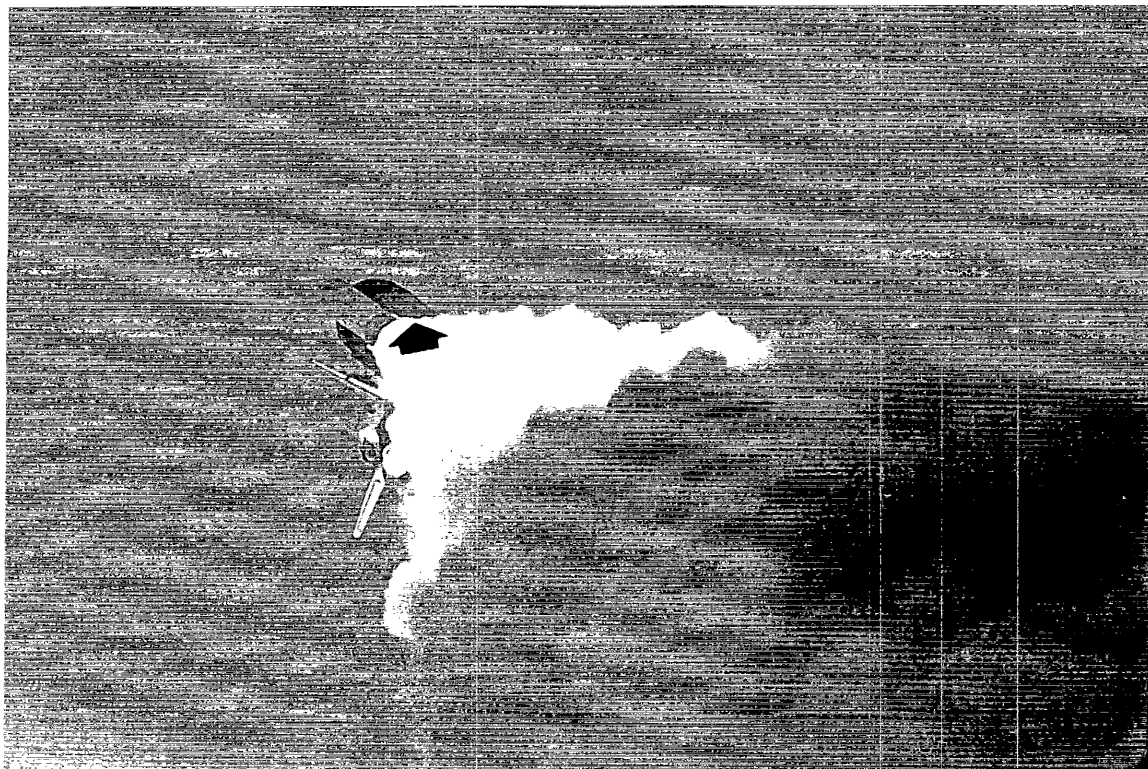
Just after the roll program, 27 particles dropped out of the SRB plume near the RH aft skirt (E-59). The particles are believed to be pieces of aft skirt instafoam due to trajectory characteristics which indicate low density material. Four particles fell out of the SRB plumes in the approximate time frame T+70 through 77 seconds and were probably pieces of SRB aft skirt instafoam or chunks of SRB propellant/inhibitor (E-204, 206, 207, 210, 218, 220).

As many as 27 particles, most likely SRB aft skirt instafoam, fall from the vehicle just after the roll maneuver (E-59)

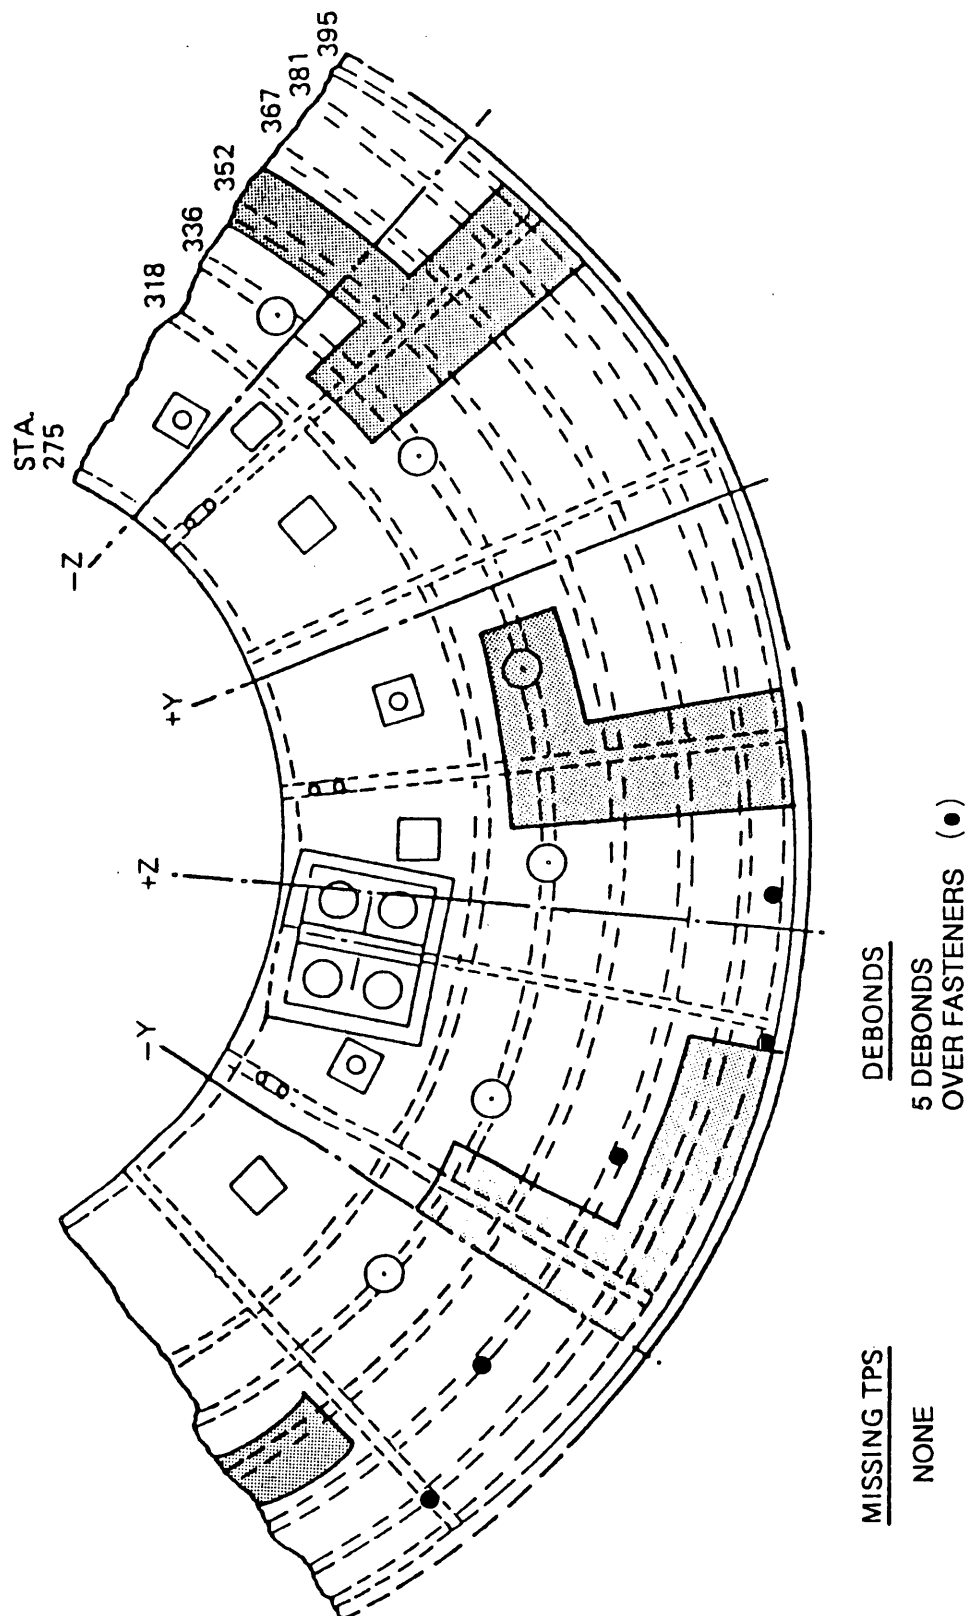
FIGURE 11. RIGHT SRB FRUSTUM

The nosecone was not recovered. The RH frustum had no areas of missing TPS but had 5 debonds over fasteners (Figure 11). The Hypalon paint had blistered slightly in localized areas. Some layers of MSA had adhered to the paint. The BSM covers were fully opened and locked in the 180 degree position.

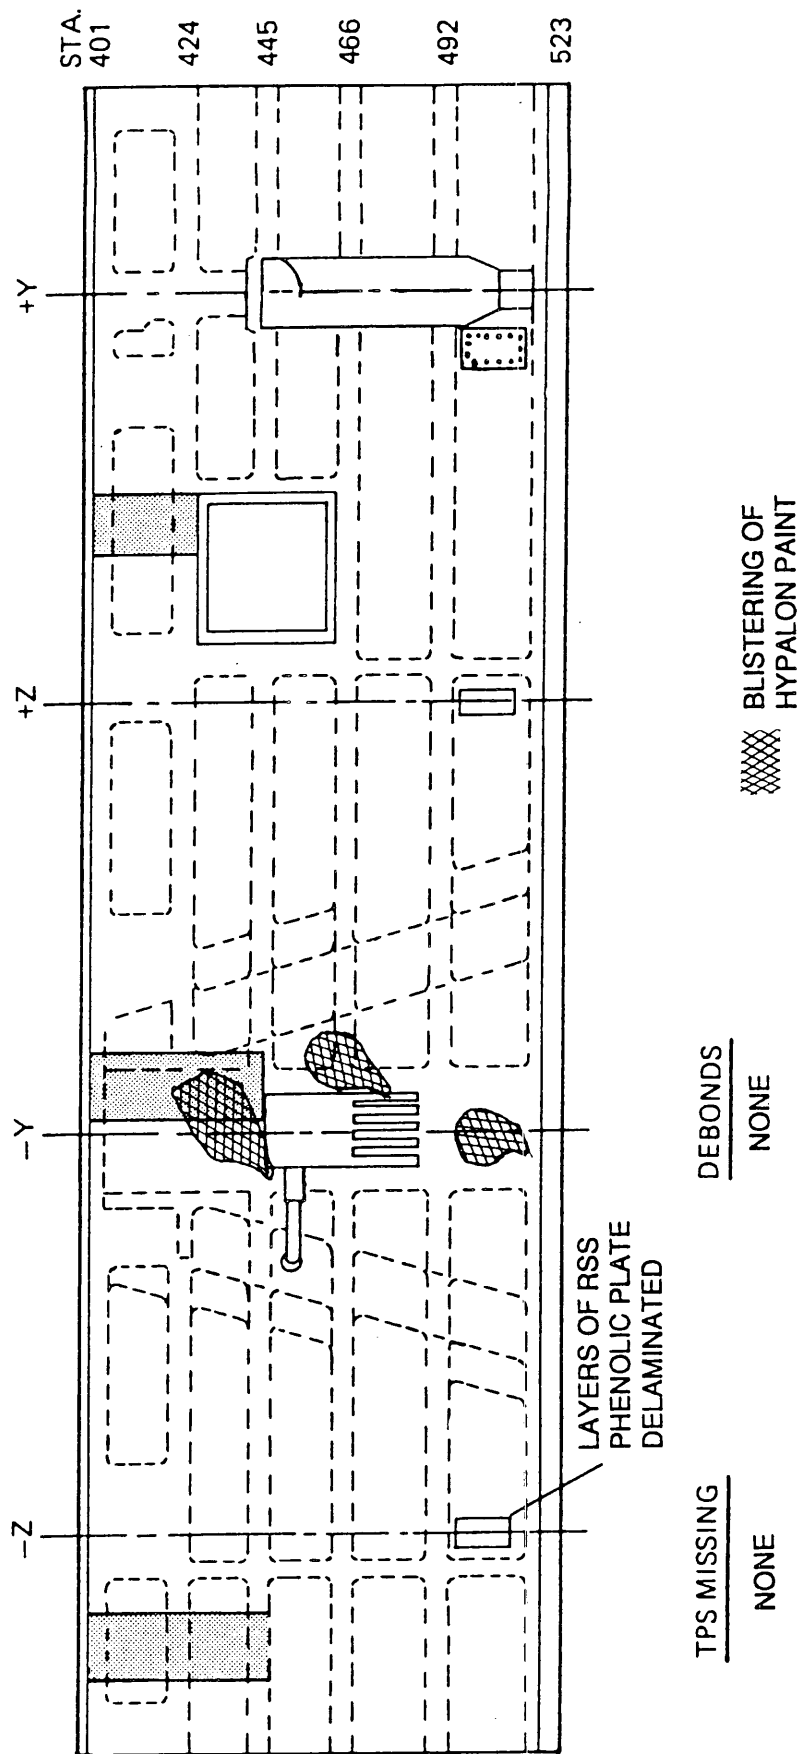
FIGURE 12. RIGHT SRB FWD SKIRT

The RH forward skirt exhibited no debonds or missing TPS. The phenolic plate on the -Z RSS antenna had some delaminated layers (Figure 12). Separation of the forward attach bolt appeared normal. K5NA closeouts on the inboard corners of the RSS interface cable tray were intact.

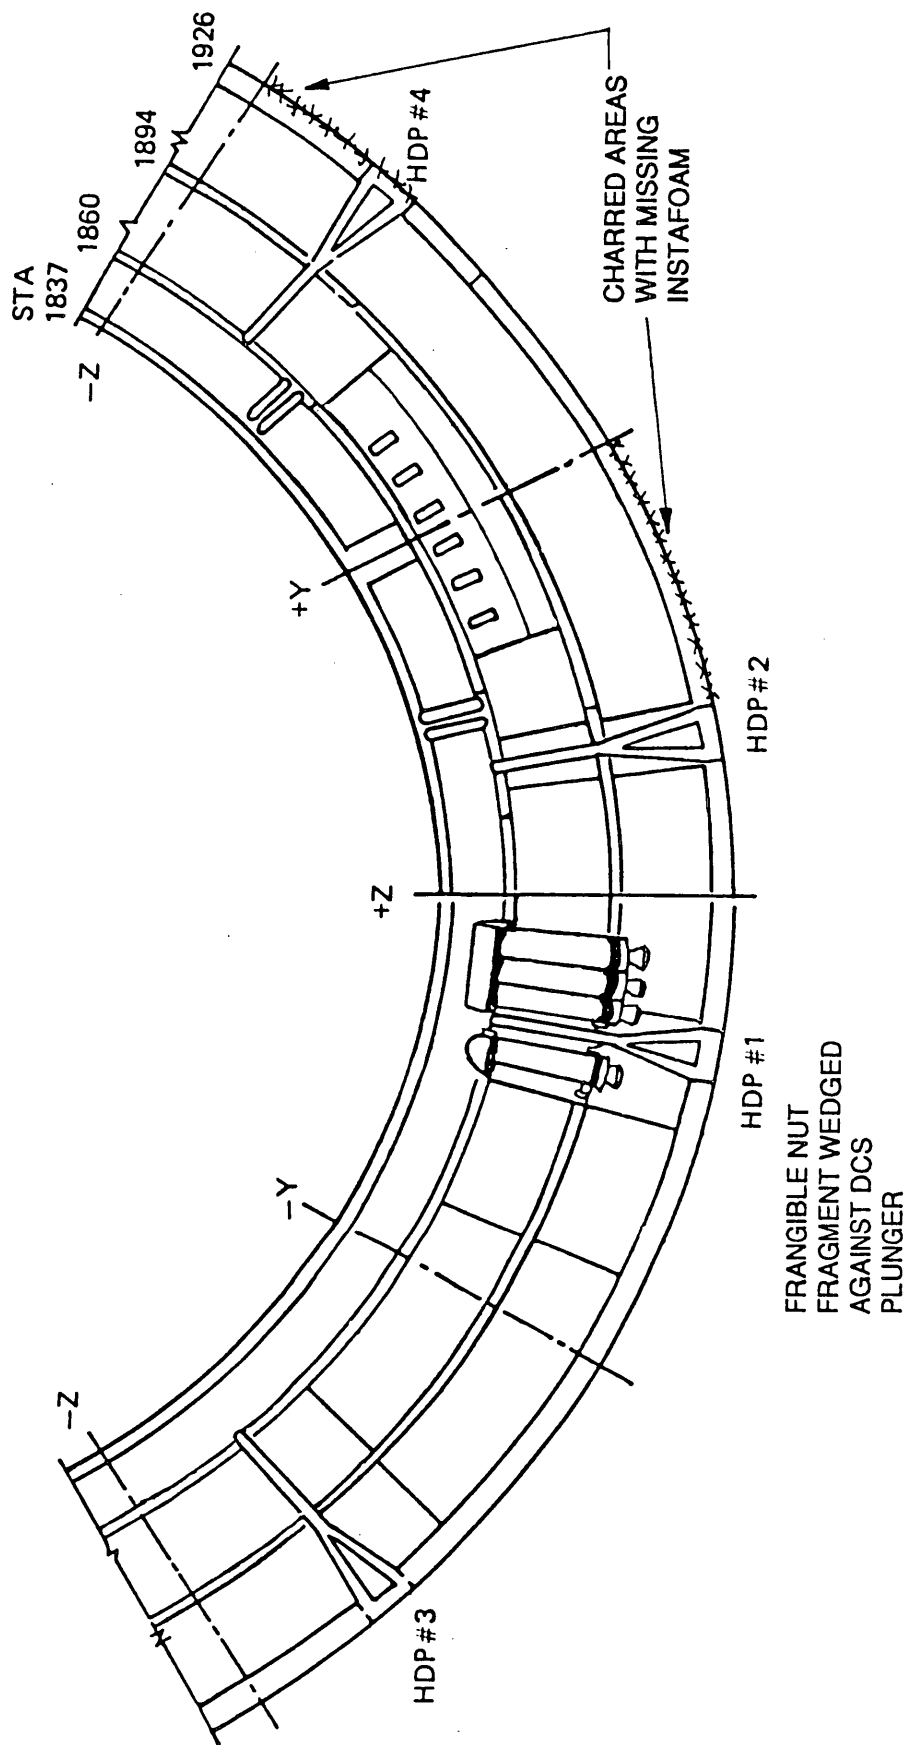
FIGURE 13. RIGHT SRB AFT SKIRT EXTERIOR TPS

The TPS over the aft skirt acreage was generally in good condition (Figure 13). K5NA was missing from all four aft BSM nozzles. The TVC system appeared to be undamaged. The phenolic material on the kick ring delaminated in several locations. K5NA thermal protective domes were missing from bolt heads on the aft side of the kick ring. A 16 x 2.4 inch maximum width piece of closeout cork was missing from the aft segment/aft skirt joint. This was considered to be an adhesive failure due to the unscooted substrate. Instafoam was missing from the aft ring around the aft skirt feet, HPU exhaust horns, and the SRB T-0 umbilical.

Debris Containment System (DCS) plungers for HDP #2, 3, and 4 were properly seated and latched, but a frangible nut fragment prevented the HDP #1 plunger from seating. There was no breaching of any post holes. There were two small 2-inch diameter sooted areas where the HDP #3 Epon shim material was missing. Twenty to thirty percent of the HDP #4 Epon shim material was missing with sooted substrate.

ALL OTHER DCS PLUNGER WERE SEATED

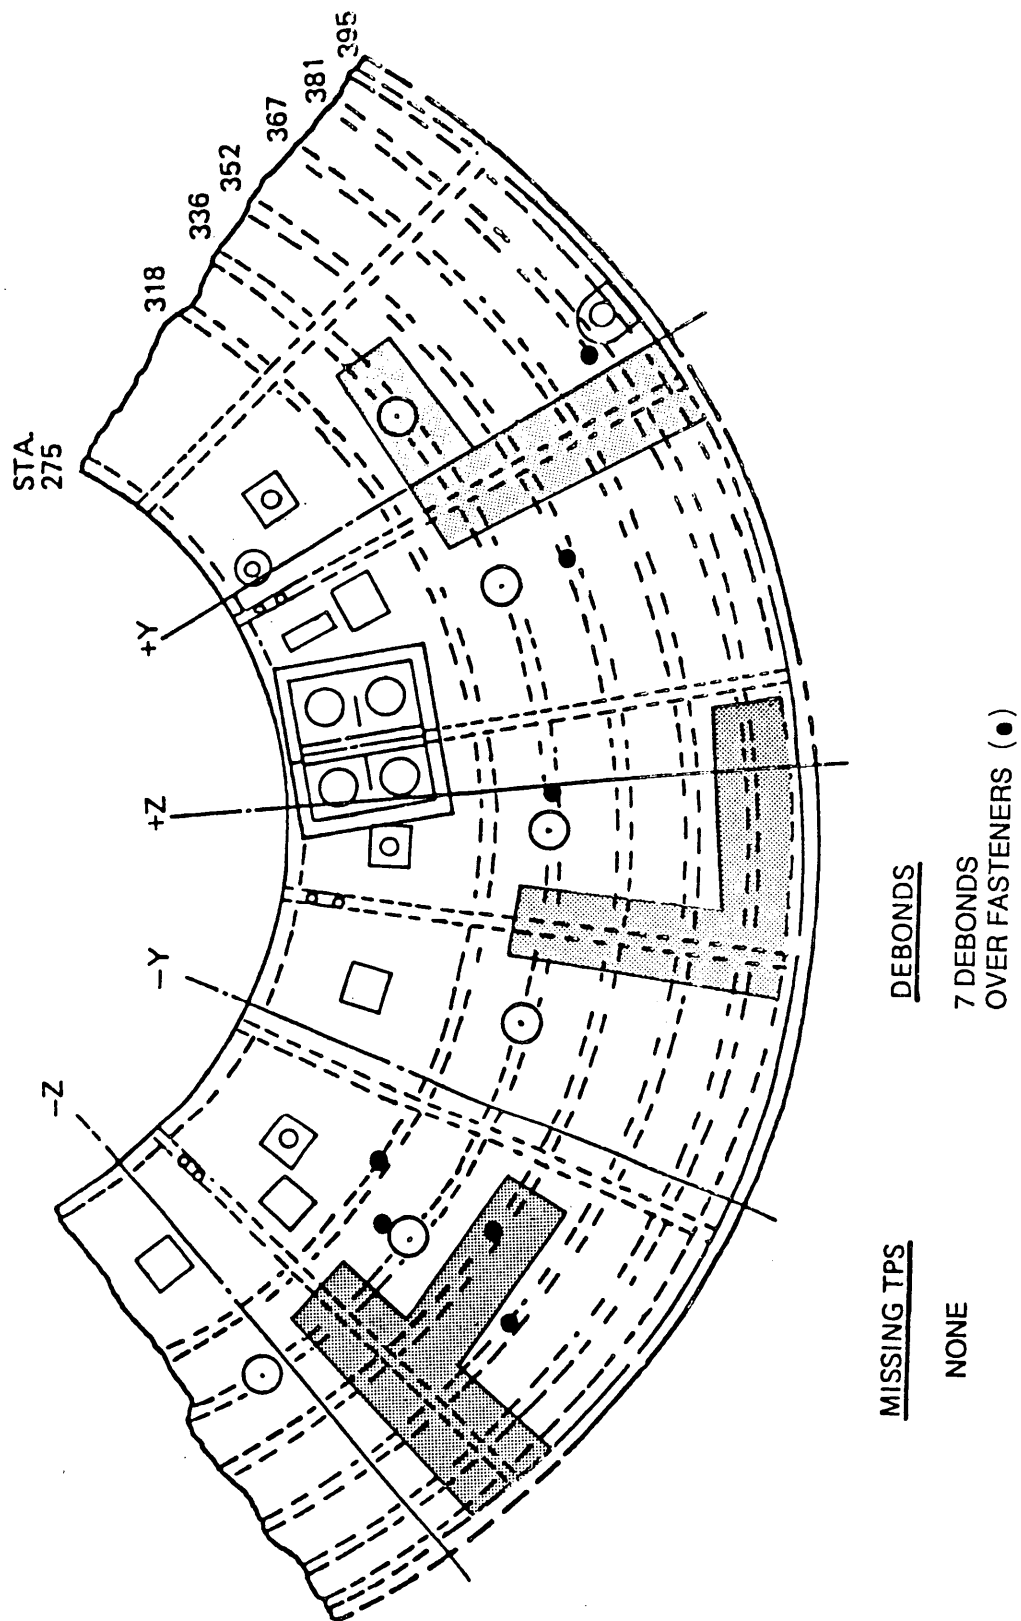
FIGURE 14. LEFT SRB FRUSTRUM

The noscap was not recovered. The LH frustum exhibited no missing TPS but had 7 debonds over fasteners (Figure 14). There was minor blistering of the Hypalon paint in localized areas. The BSM covers were fully opened and locked in the 180 degree open position.
